TOOLS DAMAGE REPORT FORM

Santhemum wealth

Machining & Fabrication

Date : 18-2-2025

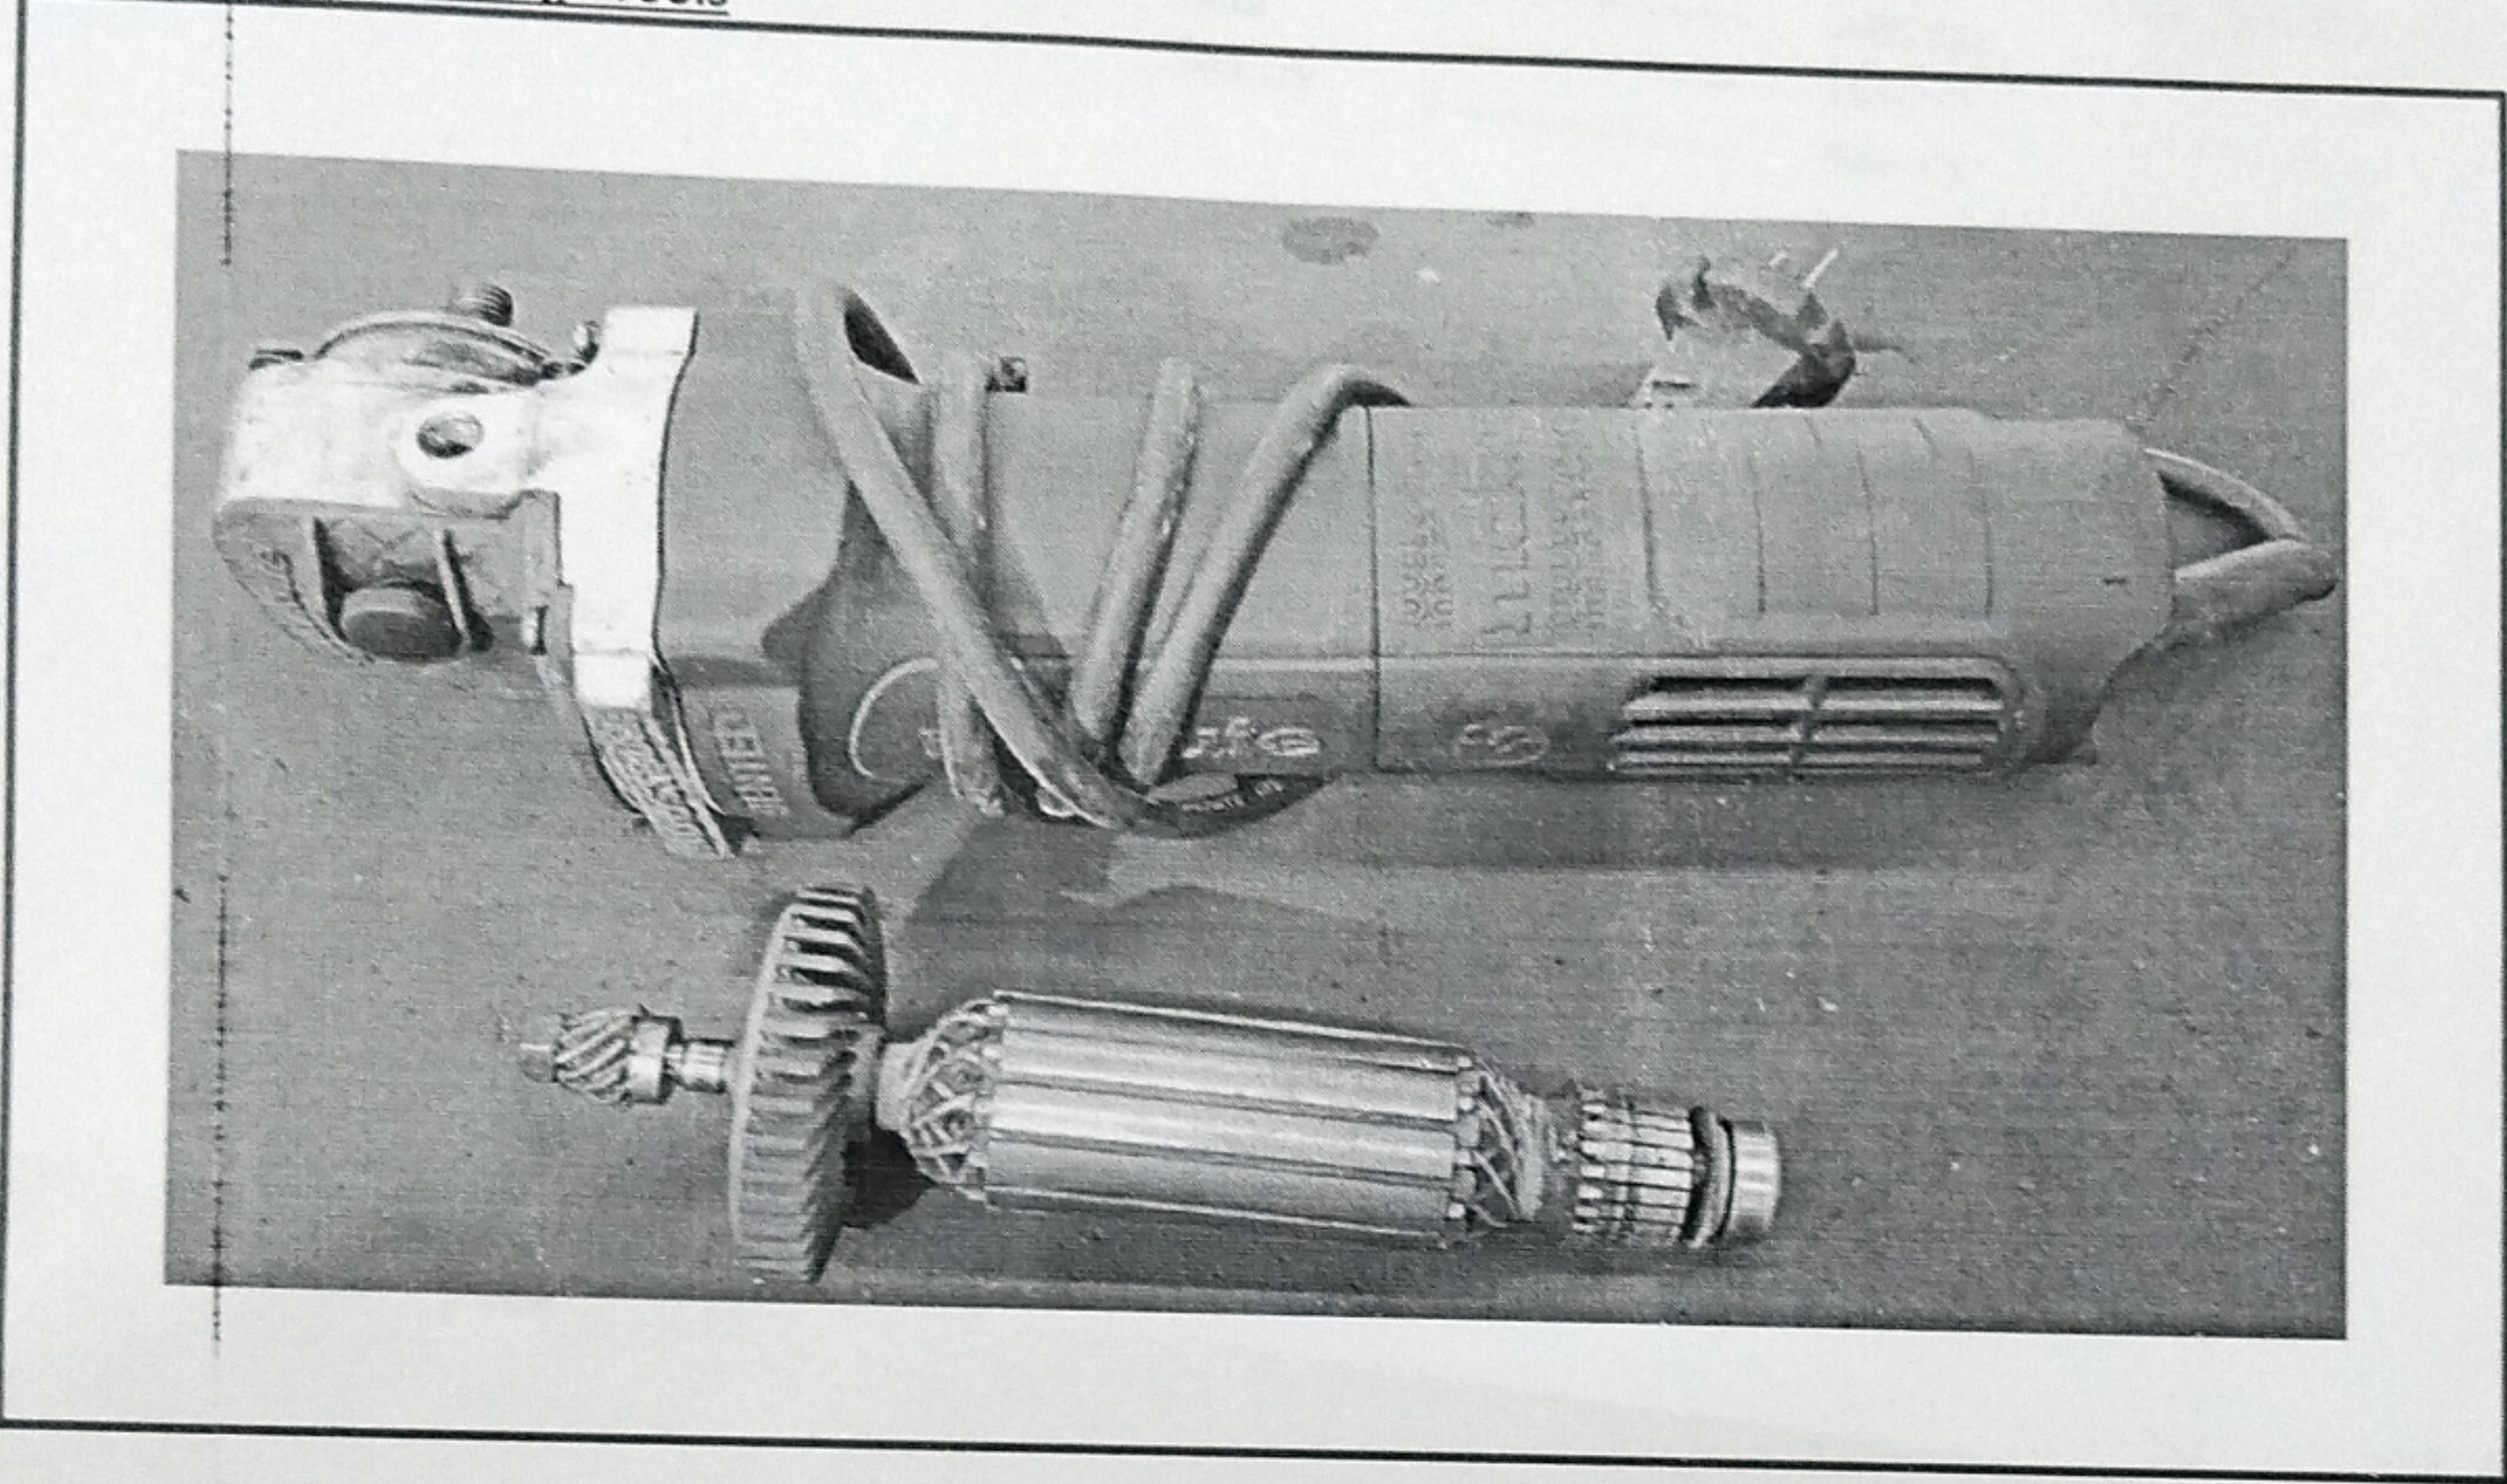
Photo attach of Damage Tools

No	Name of Tools	Code of Tools	Brand	Country Made	Qty	Damage or Lost problem Description
1	Hand Grinder	4"	Makno	-	1

Hand grinder's armature coil is scorched. So, we repaired it for (2 time). Now, it can't be repaired. We need a new grinder. because of grinding job. in M&F section
